# MBE-Corrosion Protection

## (For coastal regions)

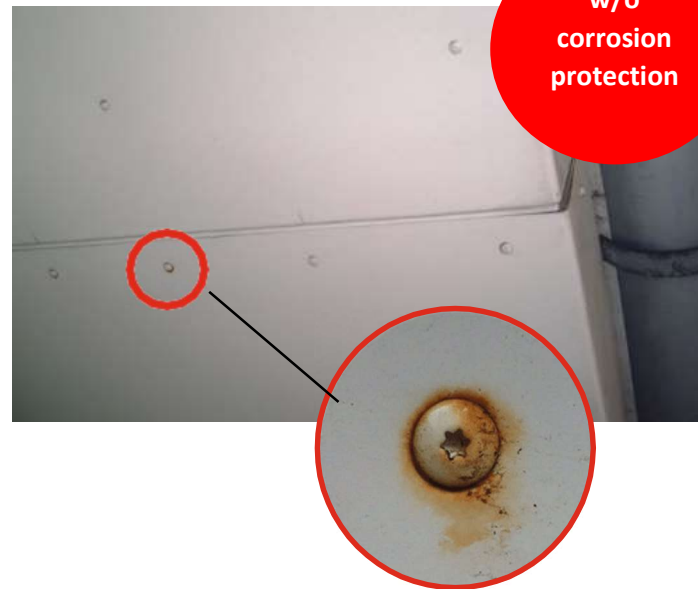
Since it has long been known that stainless steel is not (always) corrosion-free, for some time now people have been talking about corrosion-resistant stainless steels and fasteners in many areas. Stainless steel fasteners affected by brown staining are usually not completely destroyed, but a permanent surface damage may remain.

w/o  
corrosion  
protection

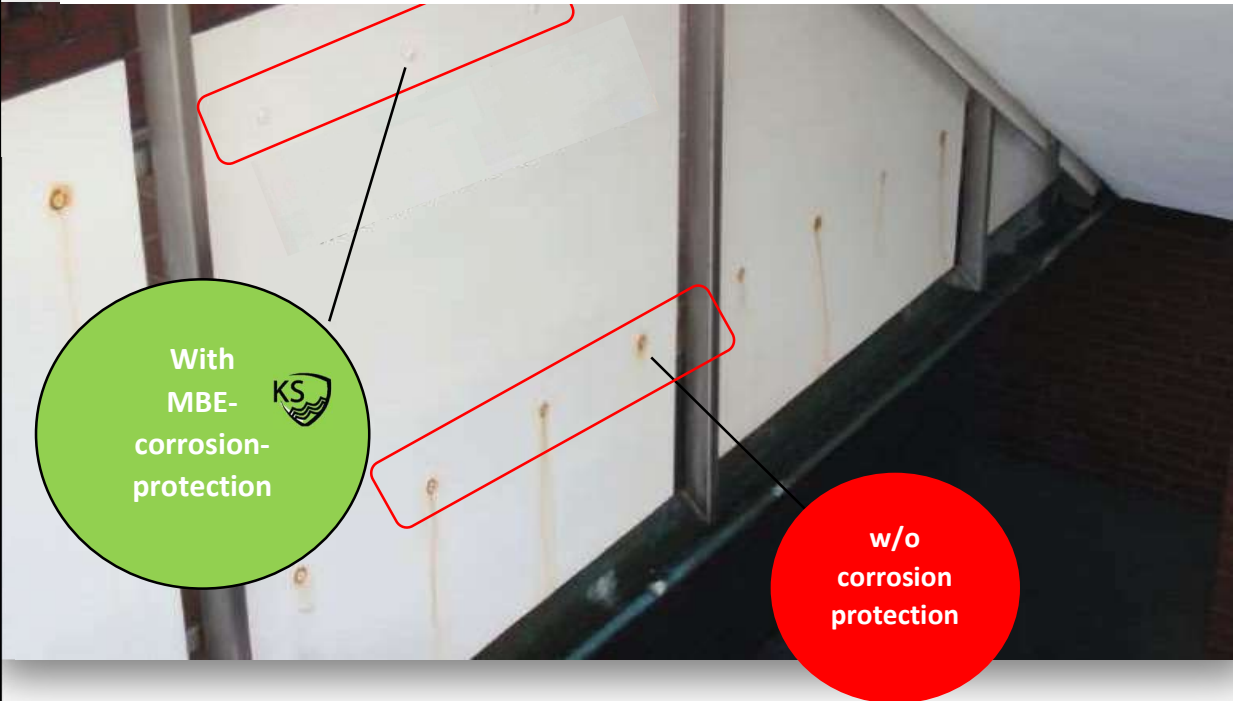
The illustration shows the fastening of HPL façade panels with stainless steel rivets on a stainless steel sub-construction.

At the time of the photo, the panels had been installed for approx. **9 months**. The specially marked fasteners (upper row of rivets) are treated with the MBE-Corrosion-Protection.
